## **Performance Evaluation of Constructed Bench Terraces in Southern Zone of Tigray Region**

### 3.1 Evaluation of Sidrkam BT in Zatta, Ofla district

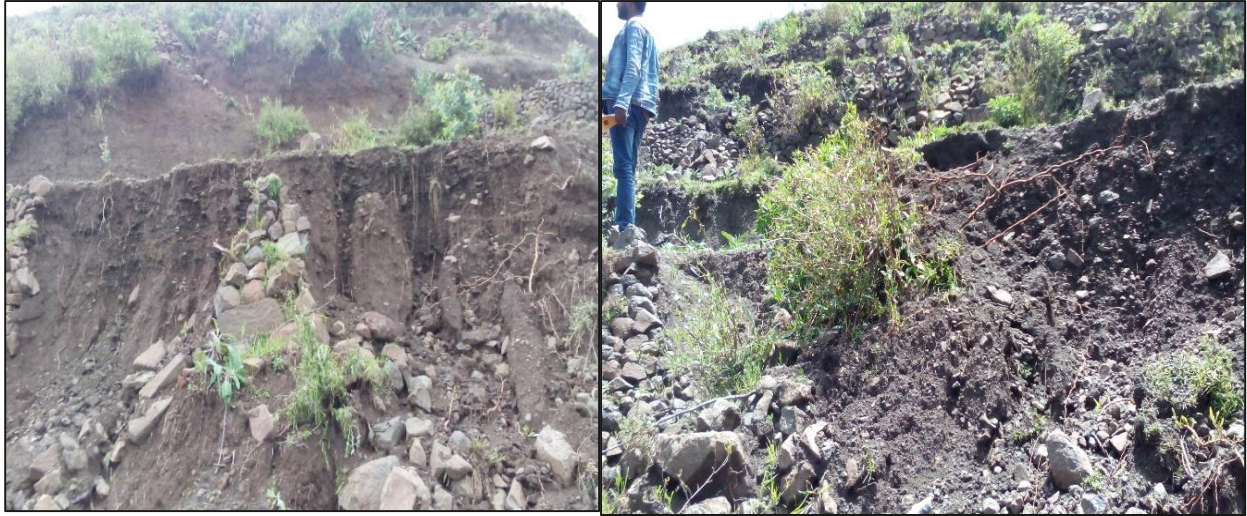
For suitable BT selection, the maximum slope for handmade BT is from 12% to 60% and should not exceed 30 degrees (60%) [12]; [13]; [14]. If the terraces are done by hand, the fitting slope range is from 7 degrees to 25 degrees (12.3% to 46.6%) [13]. However, the site in Sidrkam BT was selected on a very steep slope of an average 78% and in sandy and very fragile soil which is beyond the recommendation for the construction of BTs. The steep slope, single line BT, the sandy soil texture and large stone placement at the top of BTs resulted in the collapse of the terraces. The terraces were not supported with biological SWC measures, no buffer zone left, free grazing and no maintenance activities were done. Almost all structures were collapsed forming gullies and changing to degraded land. There was no water source for the terrace and eucalyptus was planted on the terraces which were not the target of constructing BTs. It takes a long time to get benefits from the perennial crops thus raising questions of economic feasibility and the maintenance and sustainability of the BT could be at risk.

*Figure 4 Collapse of terraces due to steep slope and fragile soil*

Inappropriate site selection, water scarcity, free-grazing and neglected maintenance, poor buffer zone, and poor stone placement are directly or indirectly major reasons for the failure of BT structures. Most of the BTs are not supported by Biological SWC materials. Site selection and technical standards of BTs should be done based on recommendations described in [9] and [13]. The participation of beneficiaries in site selection and layout can reduce the failure of BT structures. The BTs have to be supported with multipurpose biological SWC on the top and bottom of the bench and the water availability problem should be rectified by a responsible body. Manual and training to responsible bodies of the BT construction have to be prepared and conducted. Economic feasibility studies should be carried out for future BT practices whether it is economical or not.

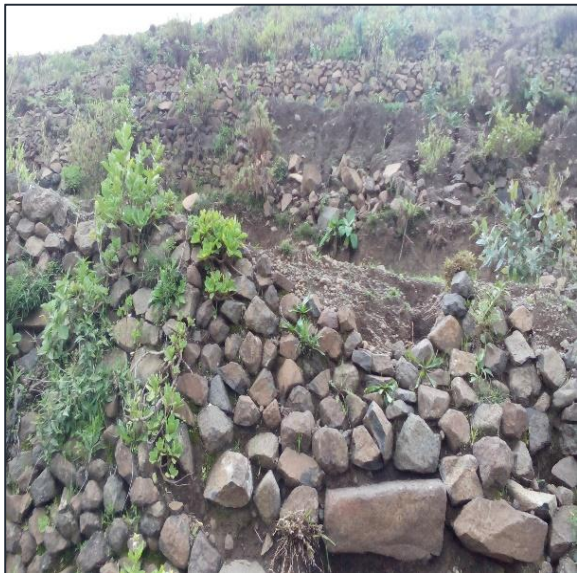
*Figure 5 Collapse of terraces due to single line stone placement, no buffer zone and not support with biological SWC practices*

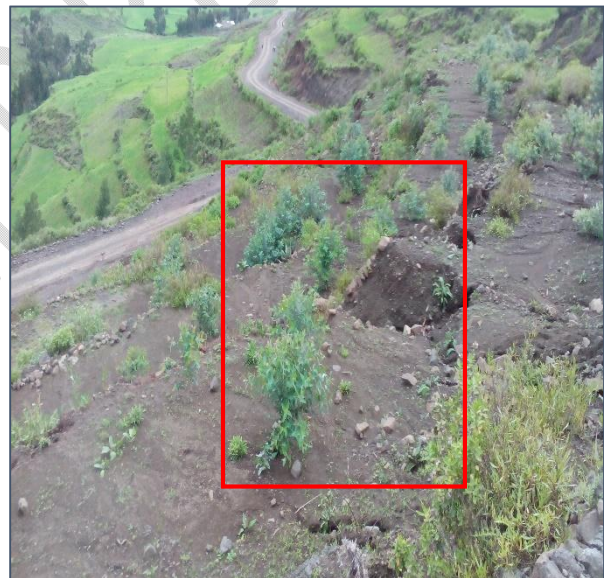
*Figure 6 Eucalyptus tree planted on BT, no waterway and source*

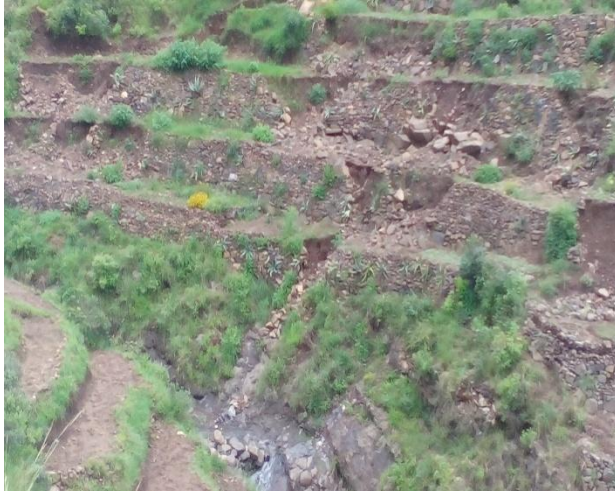
The BT in Firkaba has no waterways, no buffer zone in some BTs and there is a collapse of structures in some steep slope (80% slope) areas. Avocado and chili were planted but production was not started yet since the water source is not sustainable and fully functional. However, BT was supported by local biological SWC practices such as '*Oleo berhana*' and '*Becium grandiflorum*'.

Figure 7 Collapse of the terrace due to not recommendable slope

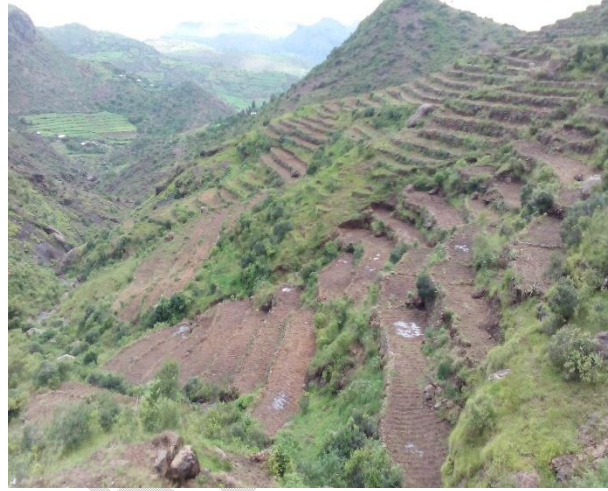
Figure 8 BT supported with local biological soil and water conservation practices, chili and avocado planted.

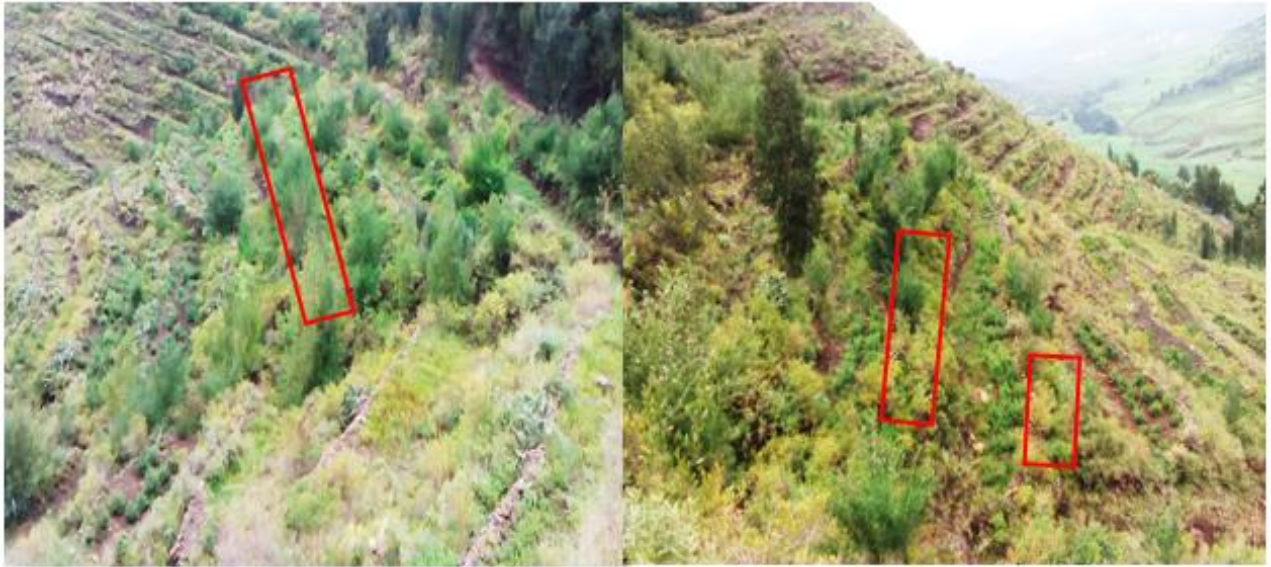
This BT was relatively more stable BT than other BTs found in the southern zone of Tigray region. It is supported by biological SWC grasses such as Vetiver, Desho, Elephant grasses and acacia species which can be used as animal fodder and some local biological shrubs and grasses. There is a better sense of ownership and maintenance of the BTs compared to all other BTs constructed in the southern zone of Tigray region. Enough buffer zones were left in most of the BTs which is good for the stability and sustainability of the BTs. It can be taken as a model for other BTs. However, since the area of the buffer zone is wider it is recommended to cover with economically important grasses, shrubs, and trees rather than making it as free space[4]; [9]. In some BTs the infertile soil has been changed to the production of cash crops such as *Rhamnus prinoides*, Potato, Onion, and Carrots due to good management and soil fertility enhancement practices. Economic benefits have been started in a member of 20 groups from *Rhamnus prinoides*, Onion, Carrot and animal fodder from the acacia trees and biological grasses. Planting biological SWC grasses/measures at the top and base of the BTs is recommended for better stability of BTs. However, water availability is the major problem in almost all BTs and the acacia species are rarely used for animal forage and this has to be changed to benefits.

*Figure 9 BT supported with Biological SWC practices, animal fodder trees and with a good buffer zone*

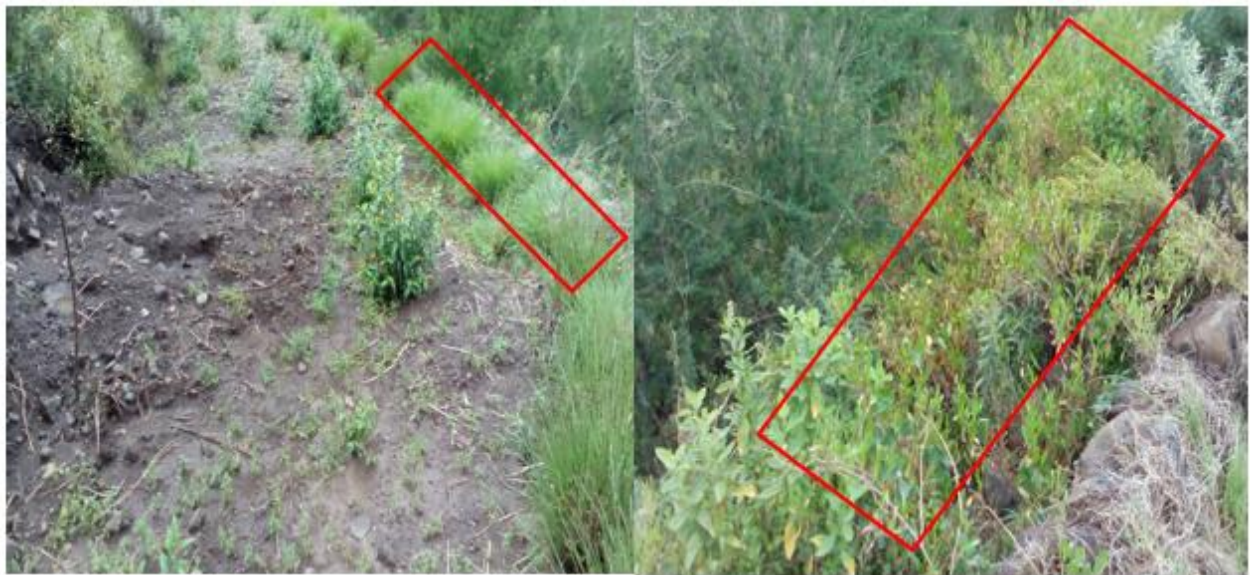
*Figure 10 BT planted with cash crops and supported with biological grasses, shrubs, and trees (both local and exotic species)*
