Investigation of the Effect of Highway Runoff along Lagos-Badagry Expressway Using Electrical Resistivity Tomography and Physiochemical Methods

**ABSTRACT**

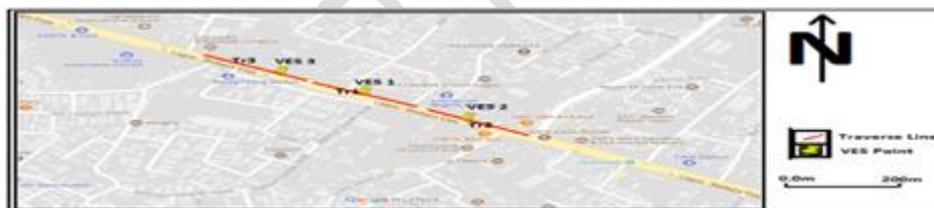
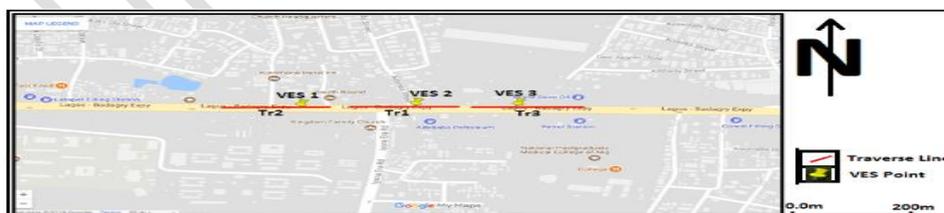
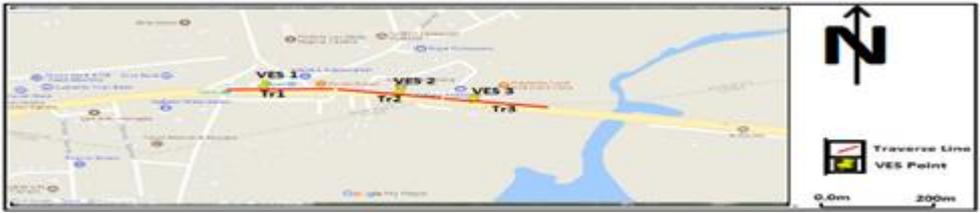
Fig. 2: Location Map of the survey data. There are three 2D resistivity profiles and VES data at each location. (a) Iyana Isashi area, (b) Iyana Era area and (c) Agbara area.

Nine profiles were established for the electrical resistivity method, and each had a length of 200 m (Figure 2). Three profiles were established in each location. The electrode spread (Wenner array configuration) for data collection along the three profiles in each of the locations used electrode spacing of 10 m, 20 m, 30 m and 40 m.

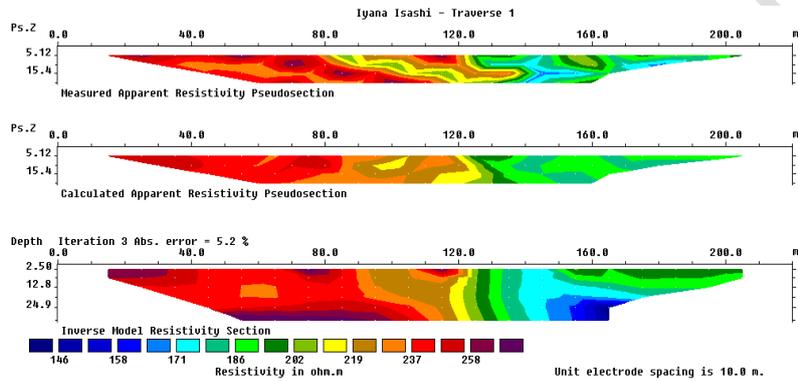
Profile 1 at Iyana Isashi

Three profiles were established at Iyana Isashi, and the results are shown in Figure 3. For profile 1, the lateral extent is 200 m. At the lateral distance of 15 m to 120 m, to a depth of 24.9 m, a formation of clayey sand was observed with resistivity value ranging from 219  $\Omega$ m to 237  $\Omega$ m while clay settlement with resistivity slightly above 50  $\Omega$ m is confined within the sand from a depth of 2.5 m to 25 m at the lateral distance of 120 m to 160 m. At the lateral distance of 40 m to 90 m, to a depth of 30 m, a formation of sand was observed with resistivity value of 258  $\Omega$ m.

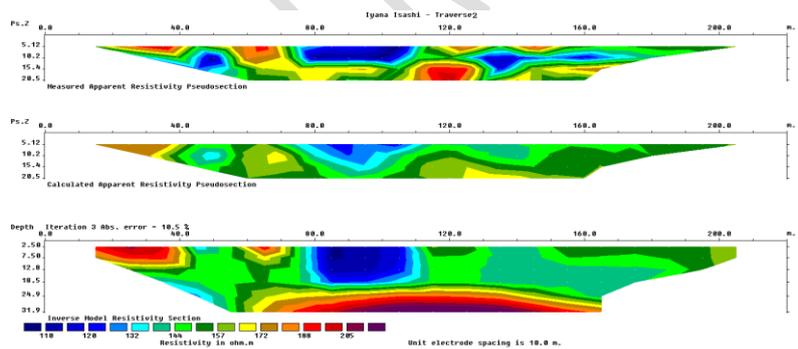
Profile 2 at Iyana Isashi

For profile 2, at a lateral distance of 15 m to 40 m to the depth of 12.8 m from the surface, a formation of clayey sand was observed with resistivity value ranging from 188  $\Omega$ m to 205  $\Omega$ m. At the lateral distance of 80 m to 100 m to the depth of 18.5m from the surface, a formation of clay was observed with resistivity value ranging from 50  $\Omega$ m to 100  $\Omega$ m. At the lateral distance 110 m to 200 m to a depth of 24 m from the surface, a formation of sand was observed with resistivity value ranging from 132  $\Omega$ m to 144  $\Omega$ m, while a formation of clayey sand was observed at the depth of 31.9 m with resistivity of 205  $\Omega$ m.

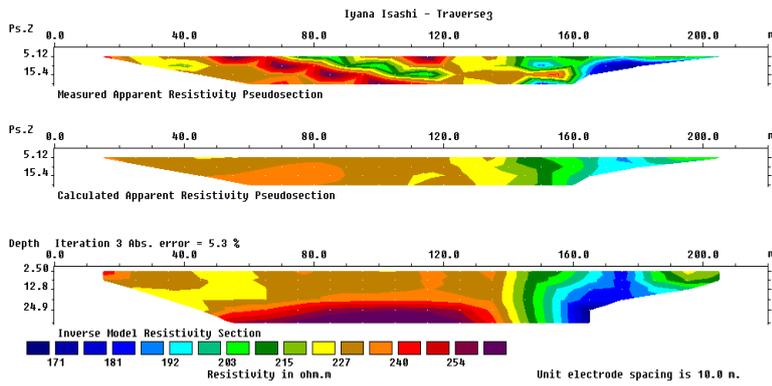
Profile 3 at Iyana Isashi

For profile 3, at a distance of 60 m to 140 m to a depth of 24.9 m, clayey sand was observed with resistivity value ranging from 227  $\Omega$ m to 248  $\Omega$ m, while a formation of clay content was observed at a lateral distance of 160 m to 180 m, to a depth of 30 m from the surface with the resistivity value of 100  $\Omega$ m. From lateral distance of 40 m to 140 m to a depth of 24 m to 30 m, a formation of clayey sand was observed with the resistivity value of 254  $\Omega$ m.

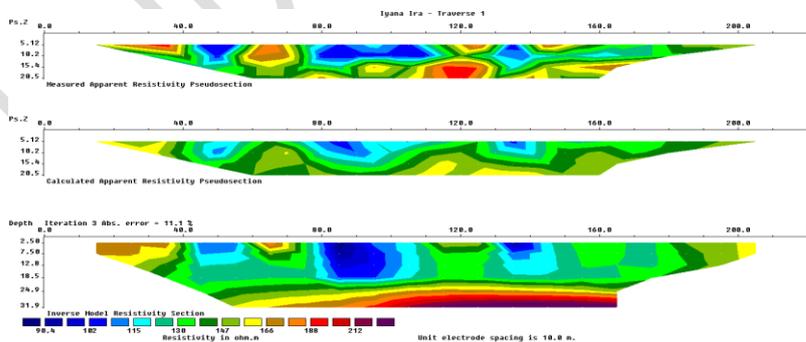
Profile 1 at Iyana Era depicts low resistivity value of  $92.4 \Omega\text{m}$  at a lateral distance of 80 m to 100 m to a depth of 25 m from the surface, indicating clay formation, while a formation of sand with resistivity value ranging from  $130 \Omega\text{m}$  to  $147 \Omega\text{m}$  was observed between 40 m to 200 m along the profile to a depth of 24.9 m from the surface. A relatively low resistivity value ranging from  $166 \Omega\text{m}$  to  $212 \Omega\text{m}$  was also observed from 90 m to 160 m at 25 m to 31.9 m depth.

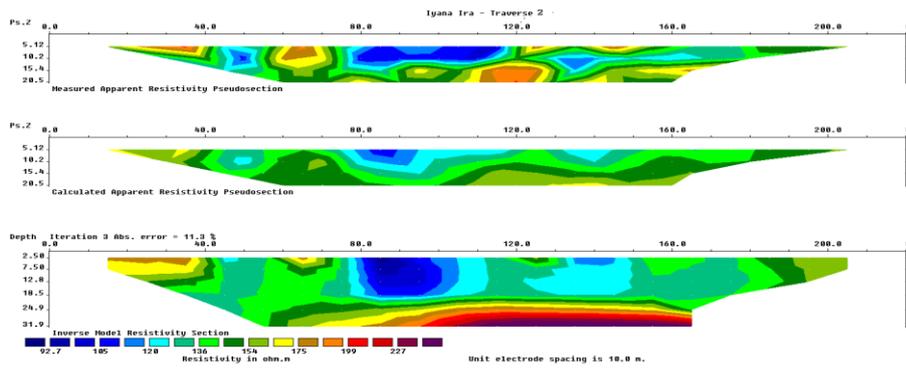
Profile 2 at Iyana Era

Profile 2 at is dominated by dry clay, mud and sand from 40 m to 200 m at depth about 31.9 m from the surface with the resistivity ranging from  $136 \Omega\text{m}$  to  $154 \Omega\text{m}$ , but clay sediment is formed within the sand and mud at 80 m to about 105 m, along the profile at depth 18.5 m from the surface with the resistivity ranging from  $92.7 \Omega\text{m}$  to  $120 \Omega\text{m}$ . At 15 m to 40 m and from 80 m to 170 m on the profile at depth 2.5 m to 7.5 m and 31.9 m from the surface are characterized by relatively low resistivity, ranging from  $175 \Omega\text{m}$  to  $227 \Omega\text{m}$ . This was observed to be clayey sand formation.

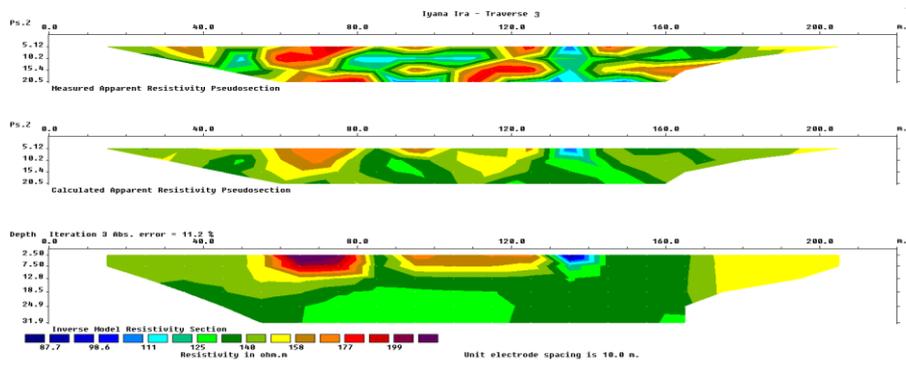
Profile 3 at Iyana Era

At 15 m to 165 m along Profile 3, from the surface up to 31.9 m depth is characterized by low resistivity, varying from  $125 \Omega\text{m}$  to  $140 \Omega\text{m}$ . Confined within this sandy clay formation, are clay formation with low resistivity value of  $87.7 \Omega\text{m}$  to  $100 \Omega\text{m}$  at lateral distance of 120 m to 130 m to a depth of 7.5 m from the surface and sandy and clayey sand with resistivity values ranging from  $177 \Omega\text{m}$  to  $199 \Omega\text{m}$  at 55;  $158 \Omega\text{m}$  at 90 m to 125 m respectively

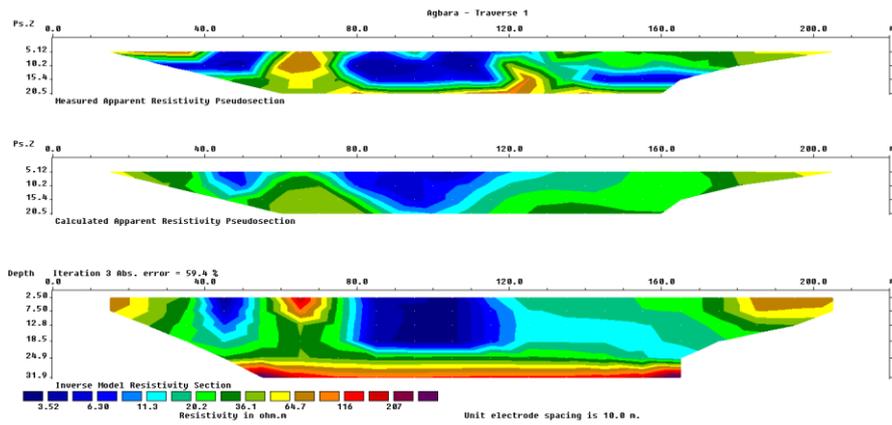
Profile 1 at Agbara

For profile 1 at Agbara, there is low resistivity ranging from 3.52  $\Omega\text{m}$  to 11.3  $\Omega\text{m}$  at lateral distance of 80m to 120m to a depth of 24.9m from the surface. This was observed to be peat mixed with clay. A large formation of clayey sand is observed at the depth of 30 m to 31.9 m with resistivity from 116  $\Omega\text{m}$  to 287  $\Omega\text{m}$ , from 40 m to 160 m spread along the profile. Above this formation is a layer of relatively low resistivity.

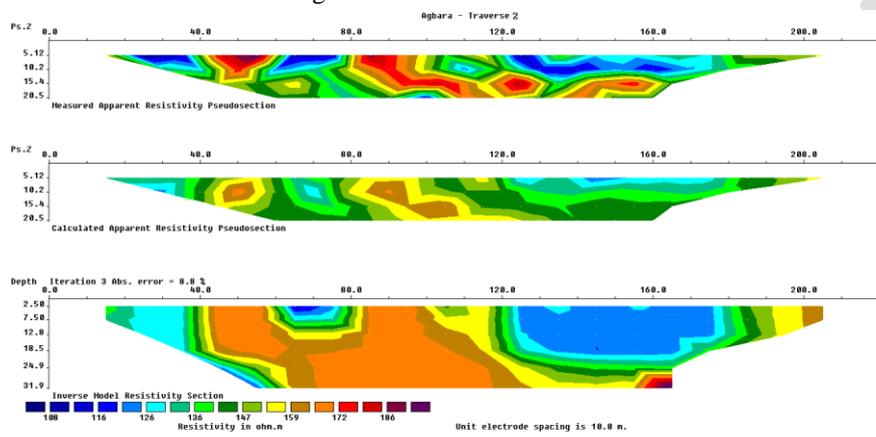
Profile 2 at Agbara

For Profile 2, from 120 m to 180 m spread and to a depth of 24.9 m from the surface, is a relatively low resistivity with value ranging from 110  $\Omega\text{m}$  to 116  $\Omega\text{m}$ . This could be as a result of clay compacted. From 40 m to 100 m lateral spread, is a zone of resistivity ranging from 159  $\Omega\text{m}$  to 186  $\Omega\text{m}$ . This was observed to be sandy

clay formation. Confined within this zone, is a local zone of relatively low resistivity of 110  $\Omega$ m to 116  $\Omega$ m at 60 m to 80 m spread and to a depth of 7.5 m from the surface.

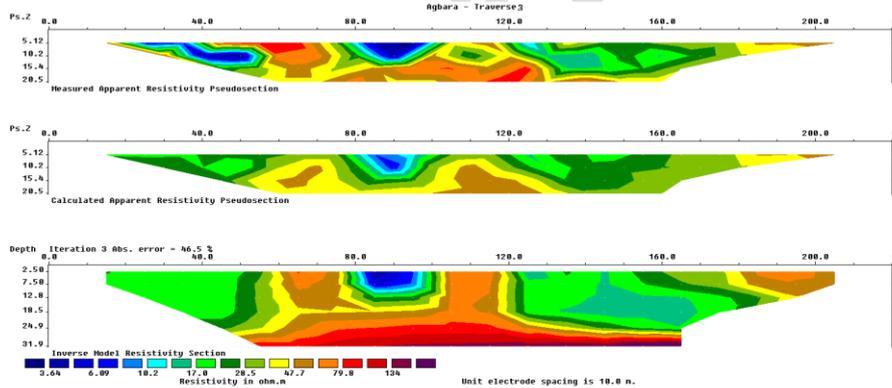
Profile 3 at Agbara.

For profile 3 at Agbara, the spread from 60 m to 120 m, from the surface to 18.5 m depth was characterized by resistivity in the range of 47.7 $\Omega$ m to 79.8  $\Omega$ m. This was observed to spread from 40m to 160 m from 34.9 m depth to 31.9 m with resistivity from 79.8 $\Omega$ m to 134  $\Omega$ m, indicating sandy clay. Within this zone, is a zone of low resistivity ranging from 3.44  $\Omega$ m to 18.2  $\Omega$ m, from 80 m to 100 m spread and to a depth of 18.5 m from the surface. This was observed to be peat mixed with clay. From 120m spread up to 180 m and to a depth of 24.9 m from the surface, is a zone of relatively low resistivity of 17.8  $\Omega$ m to 22.5  $\Omega$ m. This was also observed at 15 m to 55 m along the profile.

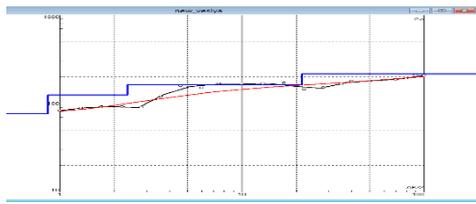
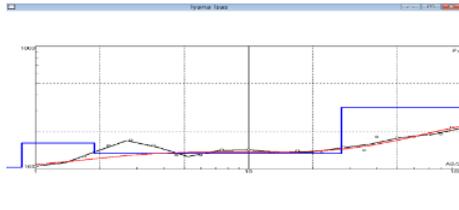
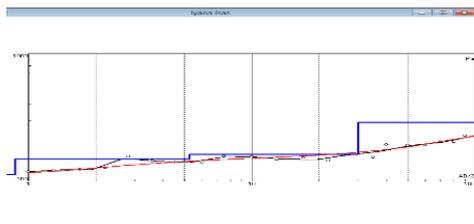
N	p	h	d	Alt
1	76.6	0.861	0.861	-0.861
2	125	1.49	2.35	-2.354
3	163	19	21.3	-21.31
4	217

N	p	h	d	Alt
1	103	0.861	0.861	-0.861
2	163	1.03	1.89	-1.888
3	134	25.4	27.3	-27.33
4	317

N	p	h	d	Alt
1	113	0.873	0.873	-0.8727
2	150	4.39	5.26	-5.262
3	163	24.7	29.9	-29.93
4	290

Figure 6: Interpretation of VES data from Iyana Isashi area. (a) VES 1, (b) VES 2 and (c) VES 3.

VES 1 in the first location (Iyana Isashi) are characterized with low resistivity of 76.6  $\Omega\text{m}$  at the first layer and thickness of 0.8 m, indicating clay formation. At the third layer, at a depth of 21.3 m, the resistivity is relatively high with a value of 163  $\Omega\text{m}$ . This layer has a high thickness of 19 m which may serve as good protective layer for the underlying rock. The fourth layer of VES 1 has a resistivity but the thickness and depth could not be determined as the current terminated within this layer. The geo-electric section of VES 2 and VES 3 are closely related; their first layers are characterized by relatively low resistivity of 103  $\Omega\text{m}$  and 113  $\Omega\text{m}$  respectively, which depict alluvium soil, while their third layers are characterized by high thickness at the depth of almost 30 m.

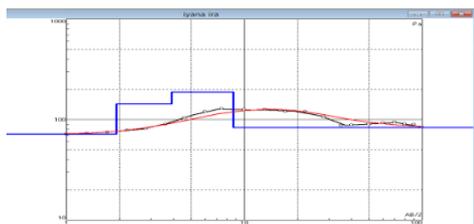
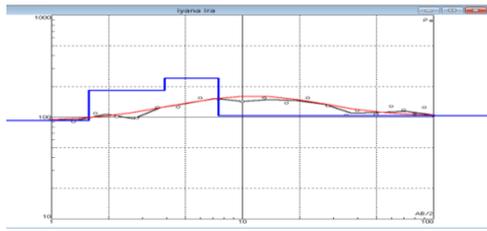
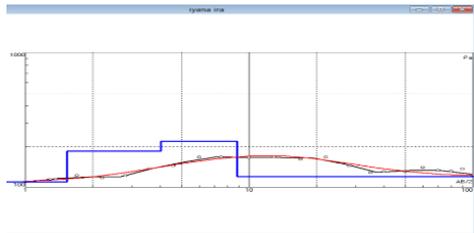
N	p	h	d	Alt
1	71.7	1.91	1.91	-1.912
2	143	2	3.91	-3.909
3	188	4.77	8.68	-8.682
4	83.3

N	$\rho$	h	d	Alt
1	92.8	1.57	1.57	-1.567
2	183	2.34	3.91	-3.909
3	241	3.57	7.48	-7.476
4	103

N	$\rho$	h	d	Alt
1	110	1.53	1.53	-1.534
2	185	2.5	4.03	-4.033
3	219	4.81	8.84	-8.841
4	120

Figure 7: Interpretation of VES data from Iyana Era area. (a) VES 1, (b) VES 2 and (c) VES 3.

For location 2 (Iyana Isashi), the first layers of VES 1 and 2 are characterized by relatively low resistivity of  $71.7 \Omega\text{m}$  and  $92.8 \Omega\text{m}$  respectively which may delineate the presence of clay content with average thickness of 3.91m. The third layers of VES 1 and 2 are relatively high, indicating the presence of alluvium soil. The first layer of VES 3 also has a relatively low resistivity of  $110 \Omega\text{m}$  at a depth of 1.53 m, while that of the second layer is  $185 \Omega\text{m}$  at a depth of 4.03 m, and the third layer has a resistivity of  $219 \Omega\text{m}$  with the thickness of 4.81m. This delineates the presence of clayey sand soil.

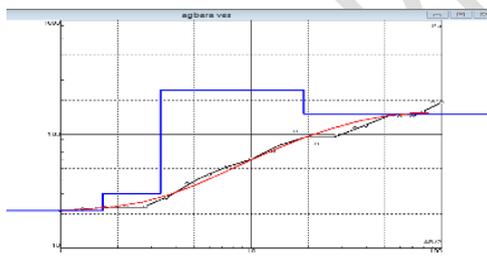
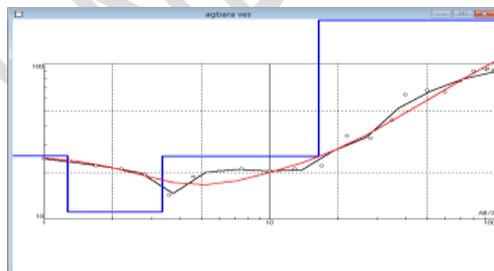
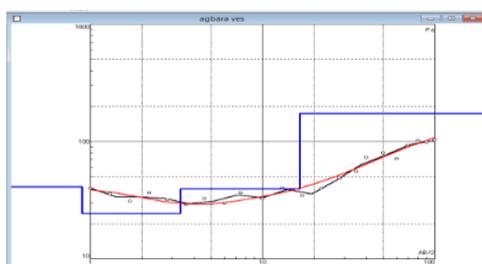
N	$\rho$	h	d	Alt
1	21.3	1.66	1.66	-1.66
2	30.2	1.68	3.34	-3.338
3	245	15.5	18.8	-18.81
4	152

N	$\rho$	h	d	Alt
1	25.6	1.27	1.27	-1.271
2	11.2	2.07	3.34	-3.338
3	25.4	13.1	16.5	-16.48
4	417

N	$\rho$	h	d	Alt
1	41.1	0.898	0.898	-0.8976
2	24.3	2.44	3.34	-3.338
3	39.4	13.1	16.5	-16.48
4	173

Figure 8: Interpretation of VES data from Agbara area. (a) VES 1, (b) VES 2 and (c) VES 3.

For location 3 (Agbara), the first layer of VES 1 is characterized by low resistivity of 21.3  $\Omega\text{m}$  at a depth of 1.66 m and thickness of 1.66 m. VES 2 is characterized by low resistivity value of 25.6  $\Omega\text{m}$ , the second layer of VES 2 has a very low resistivity of 11.2  $\Omega\text{m}$  at a depth of 3.34 m, indicating a zone of possible contamination. The third layer for VES 2 has a resistivity of 25.4  $\Omega\text{m}$  and thickness of 13.1m at the depth of 16.1 m. This is also a zone of possible contamination, which could be as a result of the infiltration of runoff at the location. At the third layer of VES 1, the resistivity is relatively high with a value of 245  $\Omega\text{m}$ , at a depth of 18.8 m and thickness of 15.5 m, which could be as a result of clay formation.

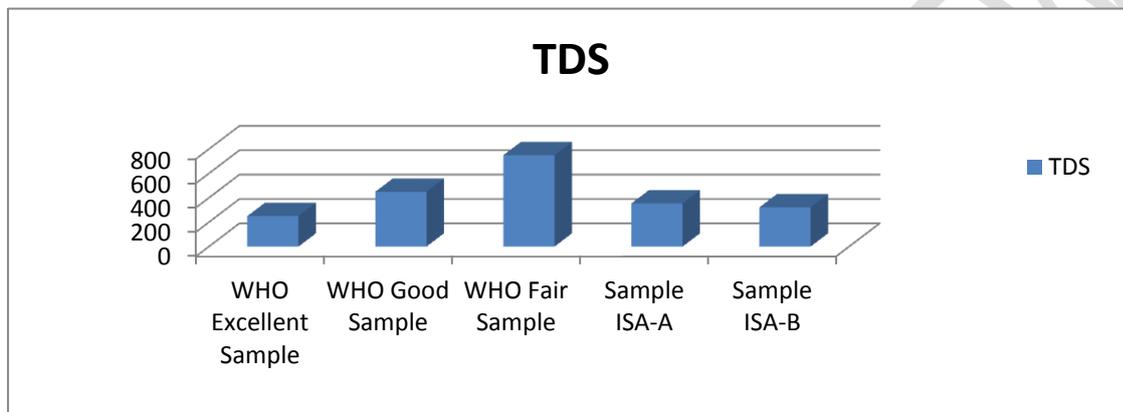
Figure 9: Microsoft Excel Chart showing the Total Dissolved solid compared to WHO at Location 1 (Iyana Isashi)

The conductivity, total dissolved solid and  $\text{P}^{\text{H}}$  values of the samples of water vary for different locations. For Isashi, the average conductivity is 254  $\mu\text{s}/\text{cm}$  for the first sample of water and 214  $\mu\text{s}/\text{cm}$  for the second sample, thus showing variation in the conductivity. The total dissolved solid is 354 ppm and 322ppm for the first and second samples respectively. The average  $\text{P}^{\text{H}}$  value for the first and second samples are 6.8 and 6.7 respectively. These values do not exceed the WHO standard for safe drinking water.

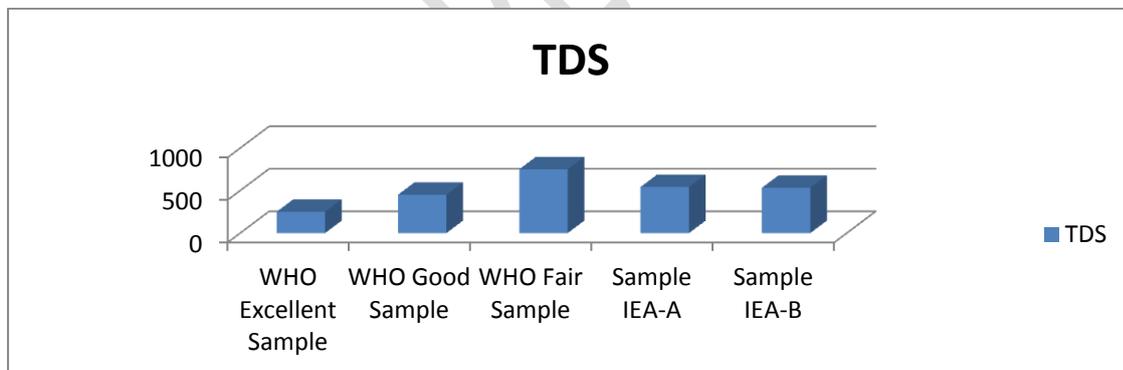
Figure 10: Microsoft Excel chart showing the Total Dissolved solid compared to WHO at Location 2 (Iyana Era)

For Iyana Era, the  $\text{P}^{\text{H}}$  is 6.9 for first sample and 6.6 for the second. Electrical conductivity is 276  $\mu\text{s}/\text{cm}$  for the first sample and 250  $\mu\text{s}/\text{cm}$  for the second sample of water. Also, while the Total dissolve solid is 542 ppm for the first sample, it is 532 ppm for the second sample.

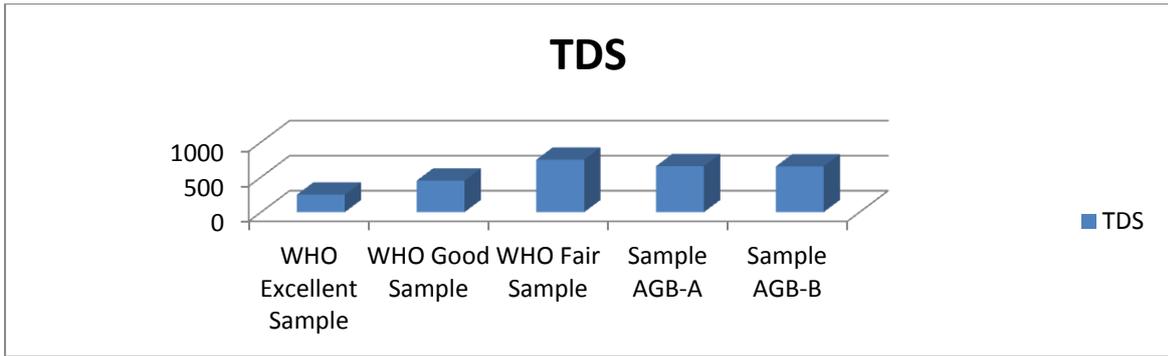
Figure 11: Microsoft Excel chart showing the Total Dissolved solid compared to WHO at Location 3 (Agbara)

Agbara shows a higher variation of Electrical conductivity and Total dissolve solids. The average electrical conductivity is 290  $\mu\text{s}/\text{cm}$  for the first sample while it is 265  $\mu\text{s}/\text{cm}$  for the second sample; although the  $\text{P}^{\text{H}}$  values are the same. The total dissolved solids is 657 ppm for first sample and 653 ppm for the second sample. The electrical conductivity of Agbara is higher when compared to other locations but it is still in the permissible state as compared to World Health Organization's standard.

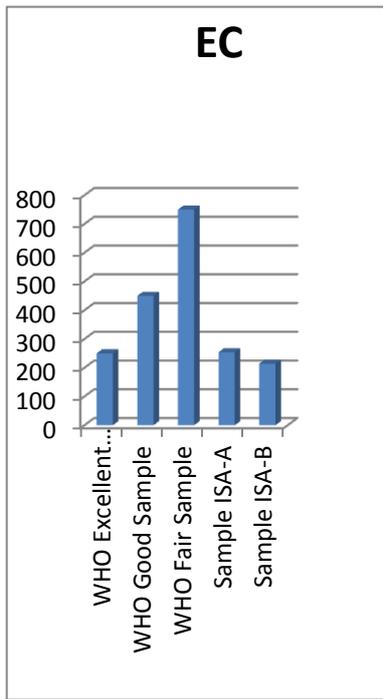
Figure 12: Chart showing the Electrical conductivity compared to WHO at Location 1 (Iyana Isashi)

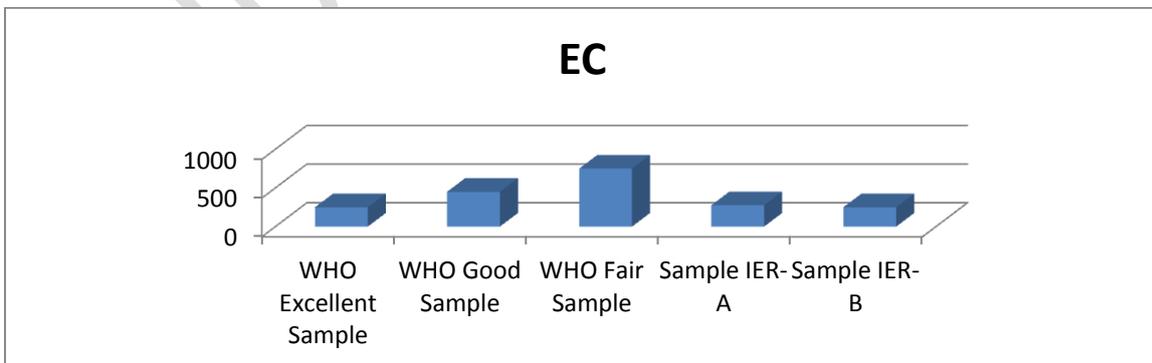
Figure 13: Microsoft Excel chart showing the Electrical conductivity compared to WHO at Location 2 (Iyana Era).

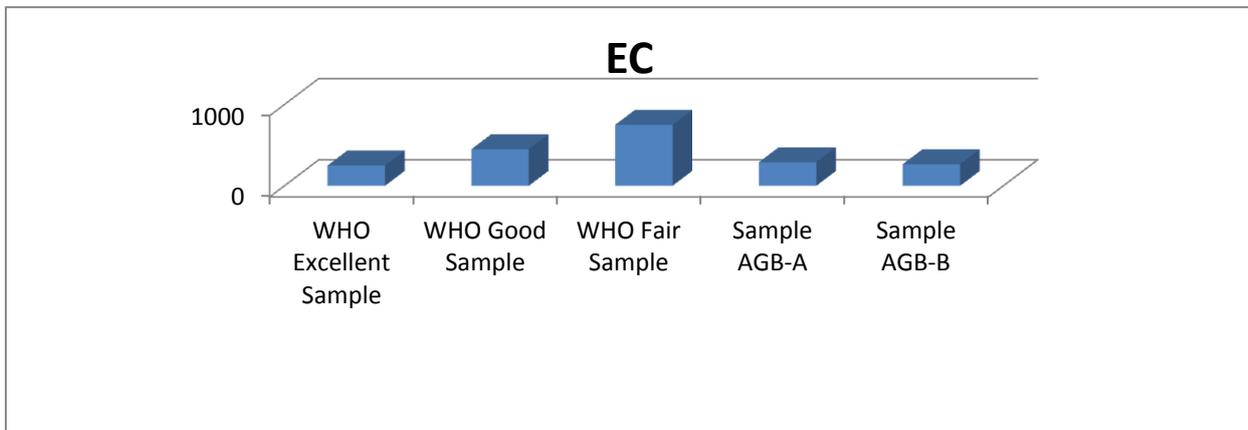
Figure 14: Chart showing the Electrical conductivity compared to WHO at Location 3 (Agbara).
