# Loosen Zipfix: a case report

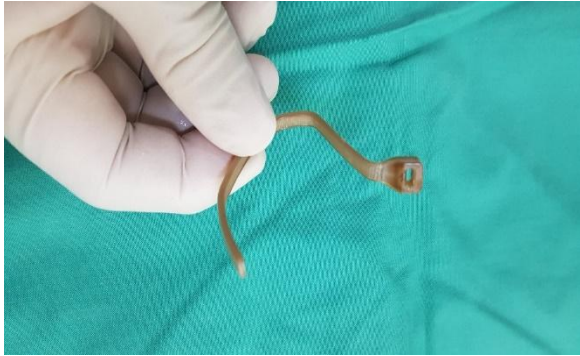
Figure 1: Sternal zipfix after removal

For this case, the extracted zipfix were reported to the company. Based on the company's analysis, a minor mark was seen on the ridge of the implant. A small amount of wear was observed on the latch within the locking mechanism. A functional test could not be performed, as the returned part was too small to reinsert into the locking mechanism to test the tightening ability of the implant. The material became too stiff to bend appropriately into the mechanism. This could be due to use within the patient's body. No other design defect was detected. Based on the analysis, no manufacturing defect was detected.

It is important to use the applicator to trigger tension of the implant fixing the sternum in place, while preventing over tension. Applicator lever able to cut the redundant end of implant avoiding undercut or overcut near the locking mechanism. All the above technique is vital for the longevity of the device. From the report, it was recommended to refer to surgical techniques.

Few caution reminded, especially when securing the sternal zipfix, the cut end must not be inserted at an angle. Excessive force of forceps when tightening the implant must be avoided and must also ensure the zipfix is properly orientated prior to insertion into the locking head.

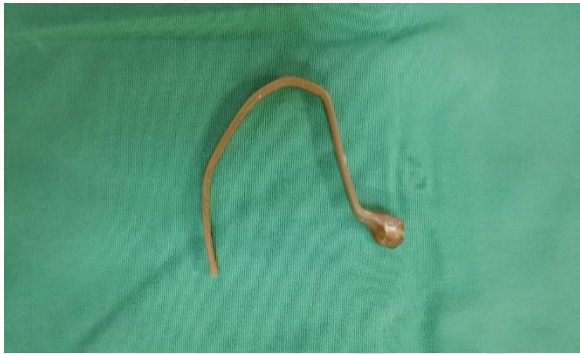
Figure 2: The material became stiff to bend appropriately into the mechanism.

Wrong technique may result into failure of the implant. We were strictly adhering to the above technique. However, the locking mechanism of the device had failed most probably due to the wear and tear component.
