## HOUSING SITUATION IN THE BAMENDA URBAN SPACE, CHALLENGES AND THE WAY FORWARD

**Abstract:** Housing is a fundamental human need, until now, making sure that every person has access to good quality housing is a grave challenge facing Bamenda Urban Space. This paper seeks to examine the housing situation and challenges to housing development in Bamenda Urban Space. The study adopted the mix method approach which involves triangulation of quantitative and qualitative methods of data collection. Primary data were obtained from field observations, interviews and questionnaires administered to households. Secondary data were obtained from relevant official documents, published and unpublished sources. Satellite imageries and ArcGIS were used to describe the pattern of growth in built-up areas between 1986 and 2019. Data from questionnaire was entered using Epi Data Version 3.1, analysed using the Statistical Package for Social Science Standard version 21.0 and presented in the form of tables, figures, plates and maps. Findings on housing situation revealed that, although the housing structures has improved, the housing designs, technology and level of maintenance are still low. The ir

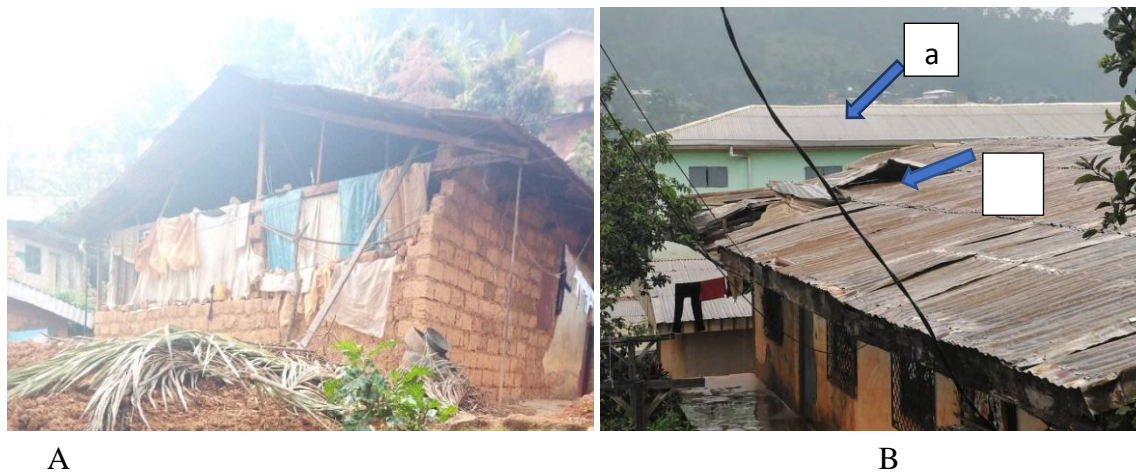
**Plate 1A:** House built with mud block and rudimentary materials in Sisia Quarter

1B: a): Shows Roofing Metal of good quality

b): Shows Roofing Metal of Very bad quality in Bayelle III

It was observed that the structure of housing in Bamenda Urban Space are not uniform, as houses are constructed site by site using diverse building materials. Field investigation revealed that 46.5% (163) of houses are constructed with mud blocks and cement, 34.1% (127) use mud blocks and rudimentary materials, 20.2% (75) use cement blocks and 1.9% (7) use stones and cement. Households in Bamenda Urban Space use metals of different sort as roofing materials. Field investigation revealed that 56.7% (211) of the houses use metal of good quality, 42.5% (158) use metal of poor quality which are very old, rusted and are most

often leaking. while just 0.8% use tiles as roofing materials. Although the structure of housing has been improved with new designs and technology, yet there is low level of maintenance in the inner-city and the use of rudimentary materials in squatter settlements as shown on Plate 1.

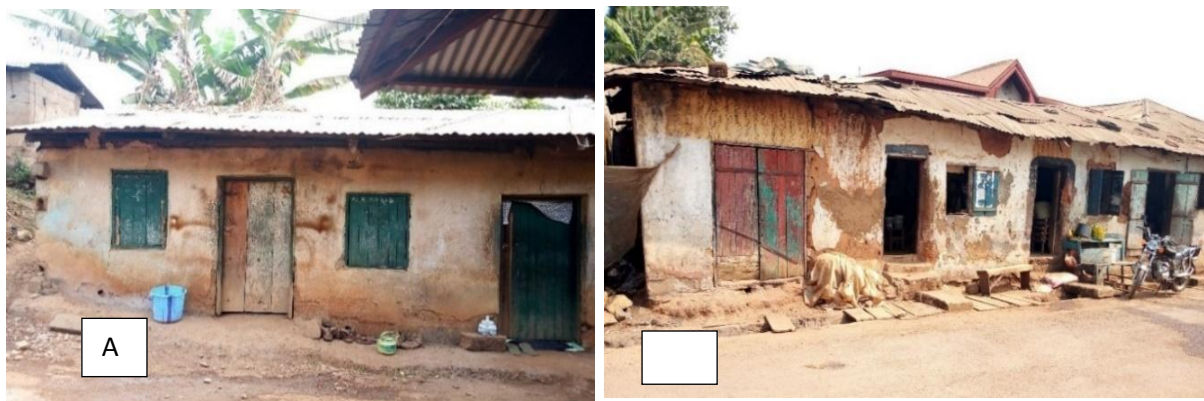
**Plate 2A:** Single room housing in need of major repairs in Old Town  
 B: Dilapidated housing quality in Old Town  
 Source: Field work, 2019

56.5% of houses in the study area are more than 40 years of age. This indicates that most of these houses have attained a state of dilapidation and depreciations as shown on Plate 2A. This finding is in line with the study of [16] who posited that new buildings tend to be more habitable than old buildings. The period between 1980 and 2000 marked the beginning of the economic crisis in Cameroon which resulted to a drop in the number of houses constructed to 18.3% (68). The crisis had negative effects on the different aspects of development, more especially on housing development. From 2000 to present, housing construction increased to 25.3% (94). Analysis on housing condition reveals that 51.9% (193) of houses are in need of minor repairs, 28.8% (107) for major repairs, while just 14.5% (54) of houses were in sound condition and 4.8% (18) were dilapidated houses as shown on Plate 2B. It was observed that, majority of the houses in the old inner-city slum neighbourhoods like Ntamulung, Atua-Azire and Old Town were in very bad condition with broken window louvers, holes on the roofs, cracks on the floors and the paint of some walls were peeling off as shown on Plate 2A.

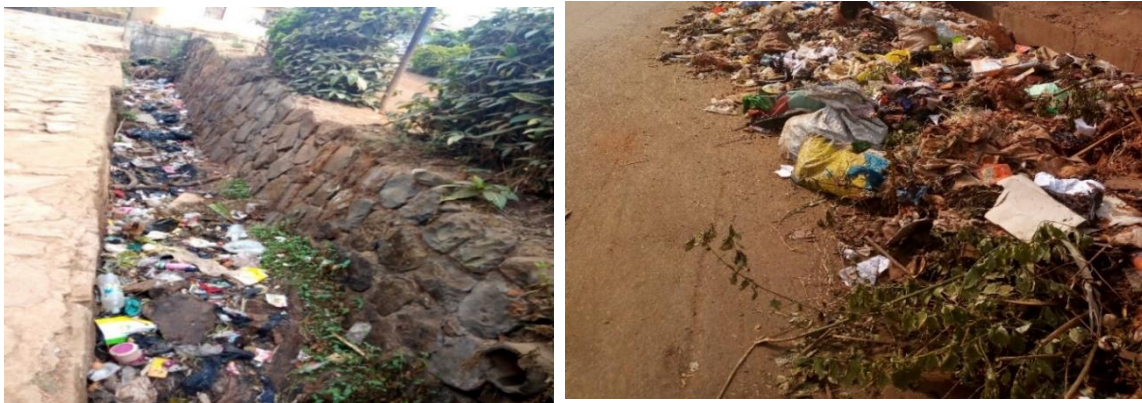
**Plate 3:** Waste Disposal in Storm Drains and on Road Sites in Old Town

dump their refuse in streams, 21.2% in pits and farms, 16.1% use waste collection (HYSACAM) cans, 14.4% burn their waste, 9.3% recycled waste, 7.8% use storm drains and 6.3% at road sites as shown on Plate 3. These poor practices have led to the contamination of the environment, especially pollution of the air, land and streams. This is in violation of section 50, (2) of the 1996 Cameroon environmental law which stipulates that, “it is strictly forbidden to deposit waste on state property” According to Section 25, waters are classified as state property, Section 28 prohibits all practices, direct or indirect that is likely to degrade the surface and ground water.
